BELZONA WATERPROOFING ON ALABAMAS TALLEST BUILDING

Customer Location: *RSA Battle House Tower, Mobile, Alabama*

Application: *RPA-Roof Problem Areas*

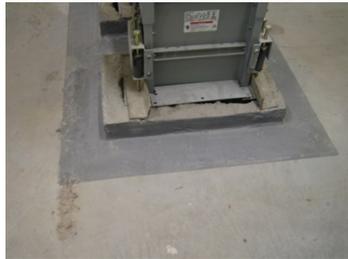
* View of the Tower , * Close up of the Belzona® 3121 , * View of the curbing , * An overview of the power lines ,

The application was carried out in accordance with Belzona Know-How System Leaflet RPA-8

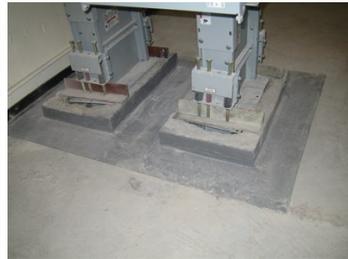
The openings on each floor that allow the power lines to travel the length of the structure were subject to water penetration between the concrete floor and curb

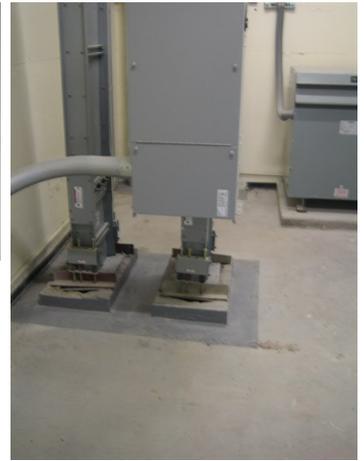
Floor penetrations for the main power lines from the ground floor to the top of the building
