BELZONA PREVENTS SLIPPING IN WASH AREA

ID: 1053

Industry: General Industry
Application: FPA-Floor Problem Areas
Substrate: Concrete
Products: Belzona® 4151 (Magma Resins)

Customer Location: Dairy, Oklahoma USA
Application Date: June, 2006

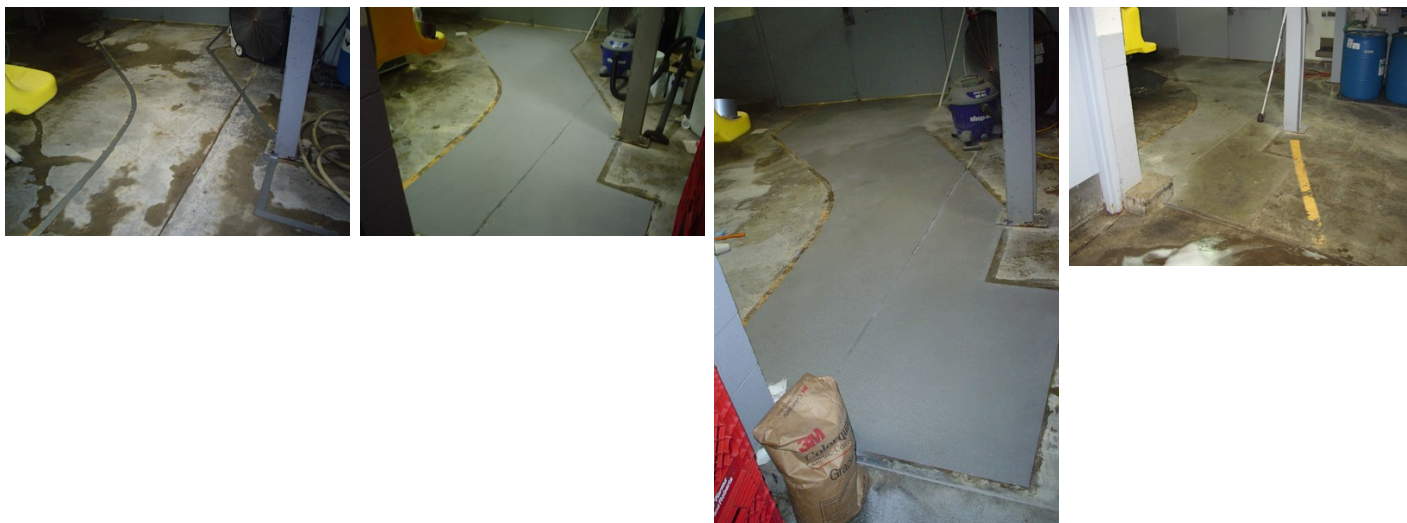
Photograph Descriptions

Previous applications of non-slip surfacing had peeled so necessitating a more permanent solution.

* Surface being cleaned , * First coat , * Second coat , * Almost two years later the floor although dirty is 100% intact ,

Walkway in wash station for casings is always wet.

Application was carried out using a modified version of Belzona Know-How System FPA-3. after thorough cleaning and abrading, two coats of Belzona® 4151 with a colored aggregate were then applied.

This floor is two years old and still in perfect condition.
