# BELZONA PROTECTS CHEMICAL CONTAINMENT AREAS

ID: 1071

Application: TCC-Tanks and Chemical Containment Areas

Customer Location: Coal Power Plant, Galicia, Spain

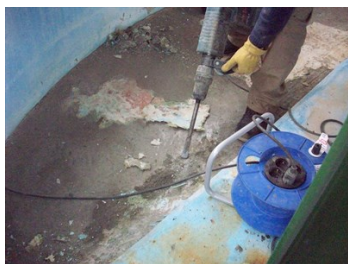
\* Removing the old coating , \* Blasting the surface to be coated , \* Applying the second layer of Belzona® 4311 over the first coat , \* One of the containment areas after one month ,
