BELZONA PROTECTS CHEMICAL CONTAINMENT AREAS

ID: 1071

Customer Location: Coal Power Plant, Galicia, Spain

Application: TCC-Tanks and Chemical Containment Areas

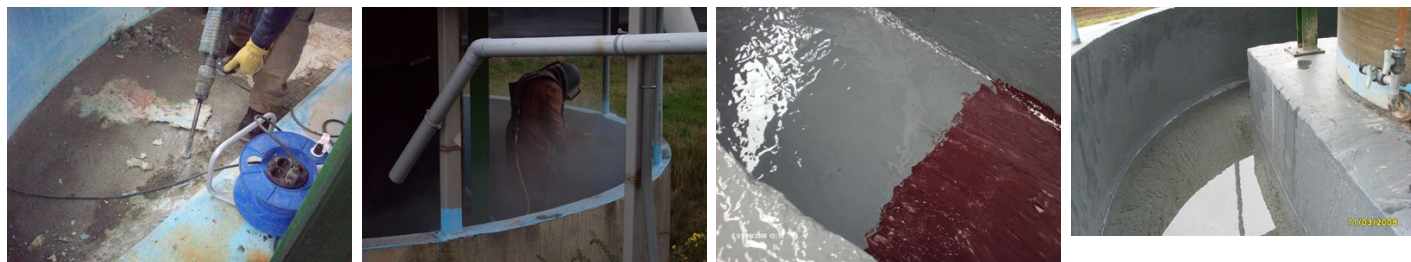
Photograph Descriptions

Occasional spills during the operations of filling up the tanks caused major damage to the previous coating

* Removing the old coating , * Blasting the surface to be coated , * Applying the second layer of Belzona® 4311 over the first coat , * One of the containment areas after one month ,

Four chemical containments for polyester tanks filled with sodium hypochlorite

Application was carried out in accordance with Belzona Know-How System Leaflet TCC-15.
