# BELZONA ELASTOMERS SEAL SF6 GAS LEAKS AT HYDROELECTRIC FACILITY

ID: 1078

**Customer Location:** Hydroelectric Facility, BC

Leaking joints Gas Insulated Switchgear (GIS)

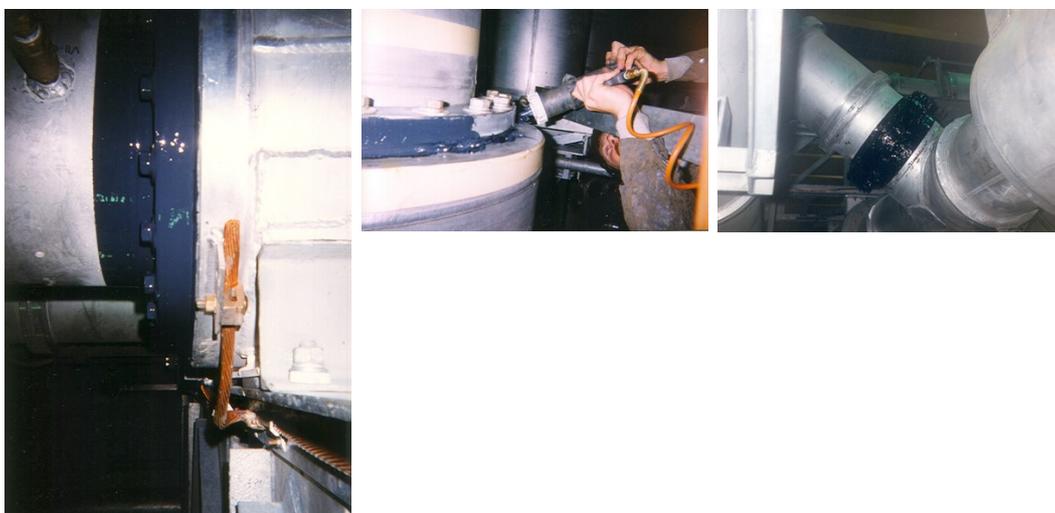
- \* Belzona® 2211 MP Hi-Build in the process of being injected into the gap between the two flanges ,
- \* Another variation of a similar application ,
- \* Another flange sealed ,

Application was carried out in accordance with Belzona Know-How System Leaflet GSS-4. Pinholes in welds were coated with

Belzona® 1321. Flanged joints were sealed with Elastomer using a combination of brush application and injection.

The Belzona materials applied in 1993 have proven completely effective with joints and welds sealed with Belzona materials remaining sealed for well over a decade now. SF6 consumption has dropped from over 50 bottles per year, to a mere two or three bottles—a saving in excess of \$1 million over the decade. Most importantly losses of SF6 into the atmosphere have been minimized, drastically reducing the environmental impact.
