BELZONA PROTECTS FILTER FROM SHELLS

Customer Location: Nuclear Power Plant, France

Application: TCC-Tanks and Chemical Containment Areas

Sea water filter for cooling water circuit of power plant.

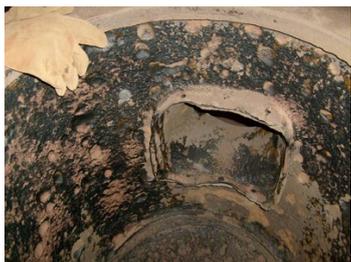
Extensive corrosion and deep erosion of metal

* State of the filter before repairs , * Filter after surface preparation and decontamination , * Filter protected with Belzona® 1321 ,

The uncoated metal was severely damaged and the efficiency of the system reduced. Belzona solution offered a durable protection against this seawater environment.
