BELZONA PROTECTS FILTER FROM SHELLS

Customer Location: Nuclear Power Plant, France

Application: TCC-Tanks and Chemical Containment Areas

Sea water filter for cooling water circuit of power plant.

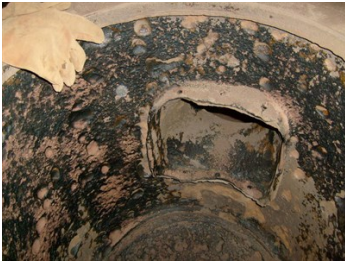
Extensive corrosion and deep erosion of metal

* State of the filter before repairs , * Filter after surface preparation and decontamination , * Filter protected with Belzona® 1321 ,
