# BELZONA PROTECTS BUND

ID: 1089

**Industry:** Chemical & Petrochemical  
**Application:** TCC-Tanks and Chemical Containment Areas

**Customer Location:** Chemical plant, Italy  
**Application Date:** February 2008

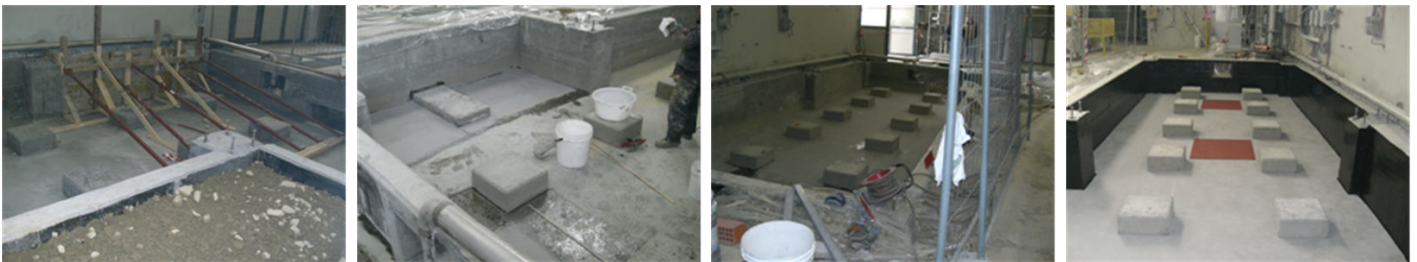
## Photograph Descriptions

- \* Construction of the chemical containment area ,
- \* Application of Belzona® 4111 ,
- \* Application of Belzona® 4111 completed ,
- \* Work completed with Belzona® 4181 and Belzona® 5811 ,

Newly built chemical containment area

Surfaces prepared by blasting. Two coats of Belzona® 5811 on internal walls, application of Belzona® 4111 on concrete base and finally Belzona® 4181 on areas in danger of accidental spillage. Work carried out in accordance with Belzona Know-How System Leaflets TCC-15
