BELZONA SEAL SURVIVES THE ACID TEST

ID: 1107

Customer Location: Petrochemical Plant, Torun, Poland
Application Date: June 2005

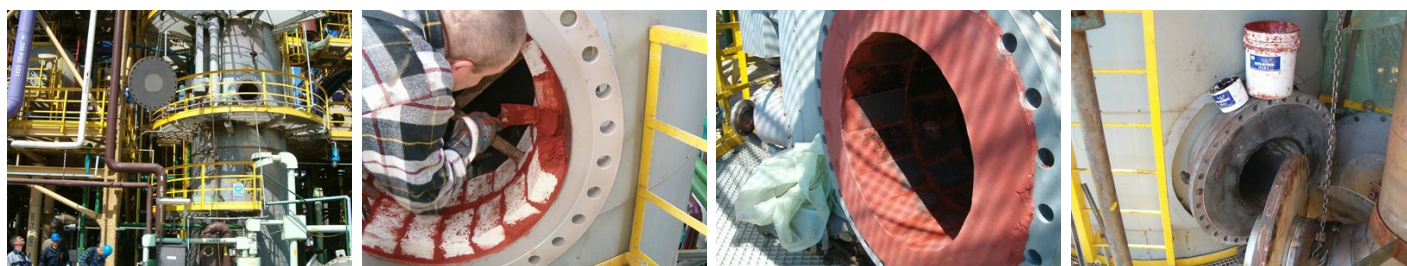
Photograph Descriptions

- * The column situation ,
- * Installing acid resistant bricks with Belzona® 4181 ,
- * The completed Belzona® 4181 application ,
- * The completed Belzona® 4341 application ,

Application was carried out in accordance with Belzona Know-How System Leaflet TCC-3. The internal lining was removed in both manhole areas. The first layer of protection used Belzona® 4181 in conjunction with acid resistant tiles. The flange faces were also protected with a lining of Belzona® 4181 composite additionally covered with Belzona® 4341 coating.

Application of the Belzona chemical resistant system allowed the column to be protected in its arduous continual service (360days per year). Inspection in June 2008 showed the Belzona to be in perfect condition.
