BELZONA HELPS UNDER FIRE

Industry: *Cement*
Application: *TCC-Tanks and Chemical Containment Areas*

Customer Location: *Cement Company, Miami, FL*
Application Date: *May, 2008*

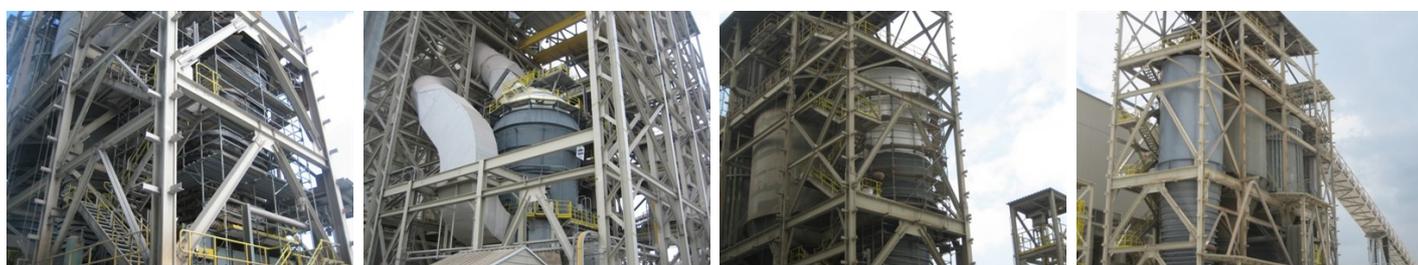
Photograph Descriptions

This is a very corrosive environment due to the nature of the raw material and the high temperatures used in the process led to serious corrosion on the plant. A serious fire, However, accelerated the situation and the bauxite bin could not be used anymore, forcing a shutdown at the plant.

- * Bauxite Bin After The Fire ,
- * Raw Mill after application of Belzona® 3921 ,
- * Bauxite Bin during first coat of Belzona® 5111 ,
- * Bauxite Bin after completion of the application ,

Application was carried out in accordance with a modified version of Belzona Know-How System Leaflets TCC-1 and TCC-5.

Belzona products have proven to be a success in the plant to prevent bridging and provide protection against the environment. Also, the quickness on the response ended saving the cement plant close to \$250,000 in operation costs. Belzona solution allowed for the

rebuilding of the seriously damaged areas with Belzona® 1121, then Belzona® 3921 and Belzona® 5111 system as the final coating providing corrosion and abrasion resistance in the hot environment.
