BELZONA KEEPS BASALT LINED DEFLAKER OPERATIONAL

ID: 1141

Customer Location: Containerboard Paper Mill, North Alabama

Application: SHM-Solids Handling Machinery

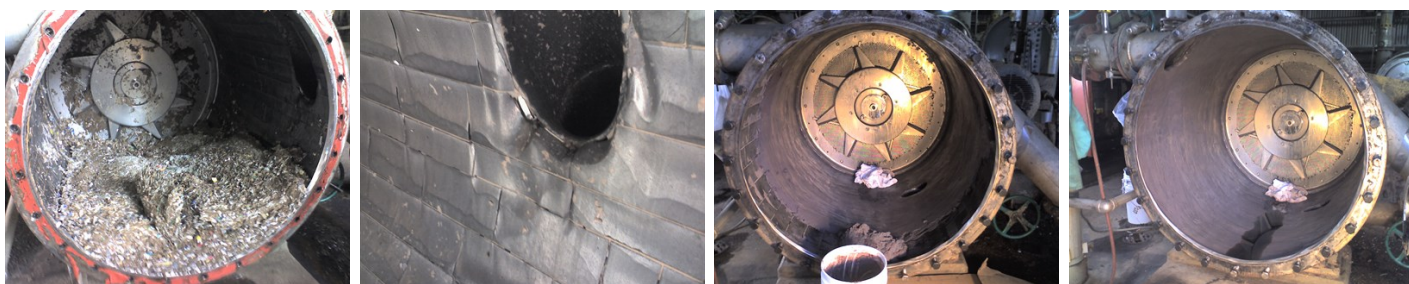
Photograph Descriptions

If this unit fails, there is a huge expense in acquiring another. Task was two fold, to line the inside with a sacrificial product and rebuild the door lip so the bolts would not pull out.

* Inside the Deflaker with trash present , * Worn Basalt tiles , * Application of Belzona® 1812 in progress , * Finished application ,

This deflaker is used to spin trash (staples, plastic, glass, metal, etc.) out of recycled cardboard. The inside is lined with basalt tiles. This is a one of a kind machine.

The application was carried out in accordance with Belzona Know-How System Leaflet SHM-13. We used aluminum oxide blast material to achieve a desired profile and applied 1/4" of Belzona® 1812 around the entire interior of the equipment. We also applied Belzona 9411 (Release Agent) on the bolts, seated them, and rebuilt the door edges with Belzona® 1111.

We offered them another alternative in that we would lay Belzona® 1812 over the tiles to act as a sacrificial layer. We now have a yearly project during their shutdowns.
