BELZONA PROVIDES SAFE LANDING PAD

ID: 1160

Customer Location: Hospital Heliport, Wyoming U.S.A.
Application Date: August 1999

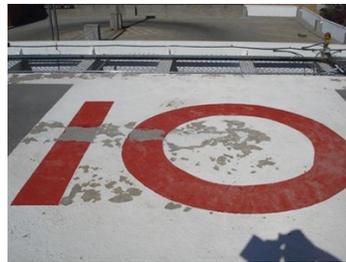
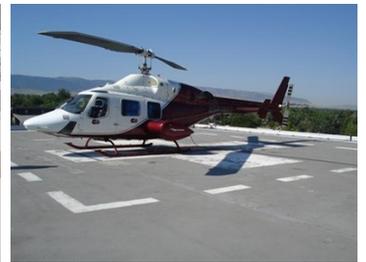
* Helipad completed August 1999 , * FAA Weight Limit Marking August 1999 , * FAA Weight Limit Marking August 2008 , * Helipad After 9 Years of Service August 2008 ,

Application was carried out in accordance with Belzona Know-How System Leaflet FPA-8.

Belzona® 5111 and 4411 (RED) were used to comply with FAA color scheme for the markings.

System still in good condition after 9 years service.
