# BELZONA PROTECTS LOADING DOCK AND RIVER

ID: 1177

Customer Location: Petrochemical Plant, South Louisiana  
U.S.A.

Application: TCC-Tanks and Chemical Containment  
Areas

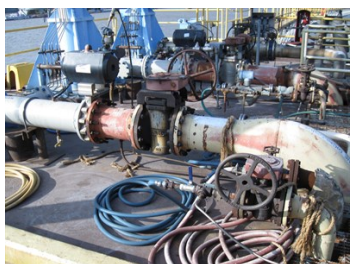
The concrete loading dock was suffering from chemical erosion and threatening to contaminate the river.

\* Overview of dock and river , \* Close-up of coating , \* Overview of containment area , \* Coating still resistant to standing caustic after 6 years service ,

The entire dock was overcoated with Belzona® 4311. Expansion joints and seams were sealed with Belzona® 2111.

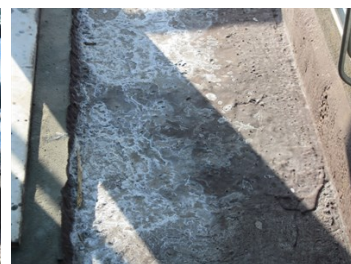
The customer is responsible for containment subject to governmental regulation and potential heavy fine due to the close proximity of the dock to the river. Belzona was able to prevent contamination of the environment. Application has been in service for 6 years, and is in excellent shape today.
