# NASA GOES WITH BELZONA

Industry:	Buildings & Structures	Customer Location:	NASA, Alabama USA
Application:	FPA-Floor Problem Areas	Application Date:	2003
Substrate:	Concrete		
Products:	<div>Belzona® 4131 (Magma Screed)</div><div>Belzona® 5231 (SG Laminate)</div>

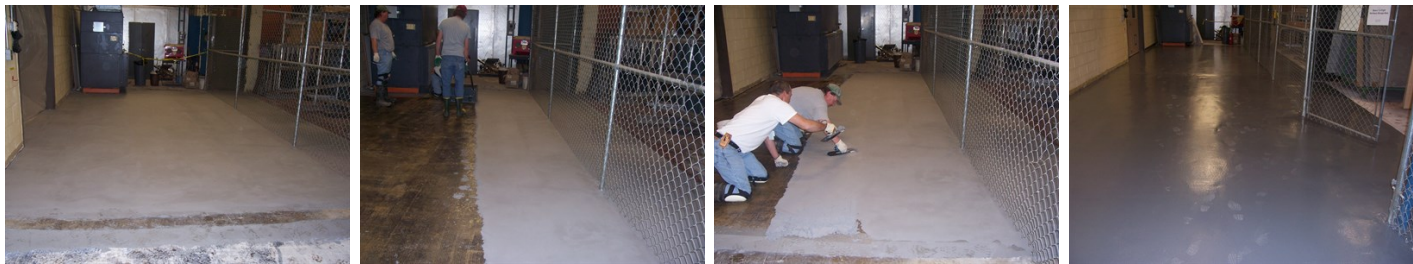
### Photograph Descriptions

Old coating and repair materials were spalling and causing uneven areas of the floor. Fork trucks and equipment being moved across it was being damaged.

\* Overall view of the floor after preparation by Blastrack , \* Screed box laying out the Belzona® 4131 , \* Smoothing out the Belzona® 4131 , \* Final coats of Belzona® 5231 ,

Application was carried out in accordance with Belzona Know-How System Leaflet FPA-1. A screed box was used to apply 1/4 inch of Belzona® 4131. After the floor was leveled out Belzona® 5231 was applied in two coats.

Old coating had failed within 1 year. Belzona has been down 3 years without any issues providing an aesthetic non-slip surface.
