BELZONA REPLACES ACID BRICK

ID: 1192

Industry: Oil & Gas
Application: TCC-Tanks and Chemical Containment Areas
Substrate: Concrete and acid brick
Products: Belzona® 4181 (AHR Magma Quartz)

Customer Location: Refinery, North Alabama U.S.A.
Application Date: 2000

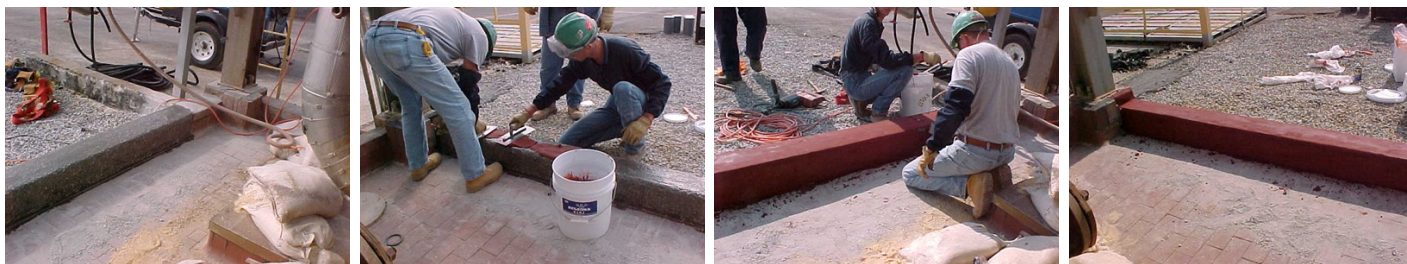
Photograph Descriptions

The new curb needed protecting to prevent acid from attacking concrete

* Applying Conditioner to the curbs , * Troweling the Belzona® 4181 , * Application underway , * Finished project ,

New curbing was installed on a pad where acid brick was previously used.

Application was carried out in accordance with Belzona Know-How System Leaflet TCC-15.
