BELZONA SEALS 20,000sq.ft.CONTAINMENT AREA

ID: 1201

Industry: Chemical & Petrochemical
Application: TCC-Tanks and Chemical Containment Areas
Substrate: concrete
Products: Belzona® 5811 (Immersion Grade) Belzona® 5111 (Ceramic Cladding) Belzona® 4521 (Magma-Flex Fluid)

Customer Location: Chemical Plant, North Alabama U.S.A.
Application Date: 2007

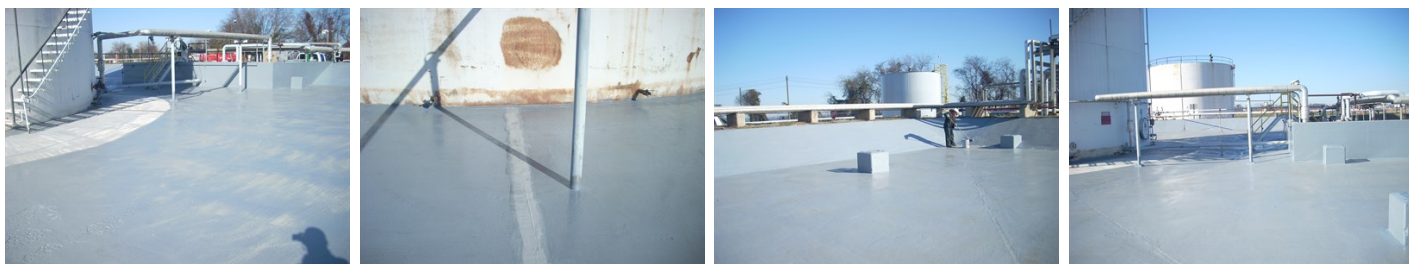
Photograph Descriptions

Cracks and failed coating over the concrete dyke.

* Over view of the containment area , * Close up of the expansion joints , * 2nd coat of Belzona® 5811 applied , * Application completed with final coat of Belzona® 5111 ,

Application was carried out using a modified Belzona Know-How System Leaflet TCC-15. The concrete was high Pressure Water Jetted to remove loose coating and expansion joint sealant. Joints then sealed with Belzona® 4521. 2 coats of Belzona® 5811 and a top coat of Belzona® 5111 for UV Protection applied to entire area.
