BELZONA SEALS 20,000sq.ft.CONTAINMENT AREA

ID: 1201

Application: TCC-Tanks and Chemical Containment Areas

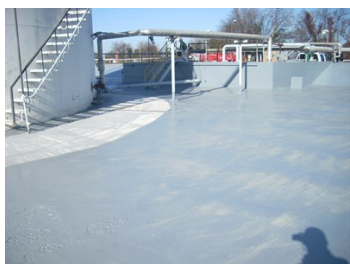
Cracks and failed coating over the concrete dyke.

* Over view of the containment area , * Close up of the expansion joints , * 2nd coat of Belzona® 5811 applied , * Application completed with final coat of Belzona® 5111 ,
