SCREED BOX MAKES SCREEDING WITH BELZONA EASIER

ID: 1204

Customer Location: *Pipe Mill, Alabama USA*

Application: *FPA-Floor Problem Areas*

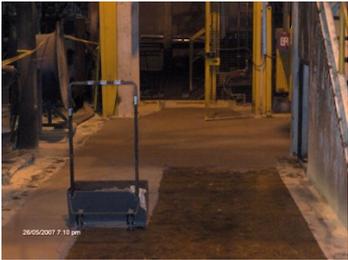
* Application to the floor starting after completing surface preparation , * Close up of the screed box , * Applying the Belzona® 4131 in strips and troweling smooth , * Air pallet jack going over the Belzona® 4131 ,

Application was carried out in accordance with Belzona Know-How System Leaflets FPA-1, -5 & -6. Screed box was used to install Belzona® 4131 at 1/4 inch over the entire floor. The expansion joint was sealed flush with the floor using Belzona® 2221.

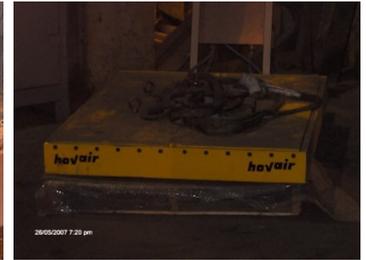
An air pallet jack was losing its seal when going across the floor.
