# BELZONA PROTECTS CAUSTIC CONTAINMENT AREA

ID: 1206

Industry: Power  
Application: TCC-Tanks and Chemical Containment Areas  
Substrate: Concrete  
Products: Belzona® 5811 (Immersion Grade)

Customer Location: Power Plant, Alabama USA  
Application Date: December 2007

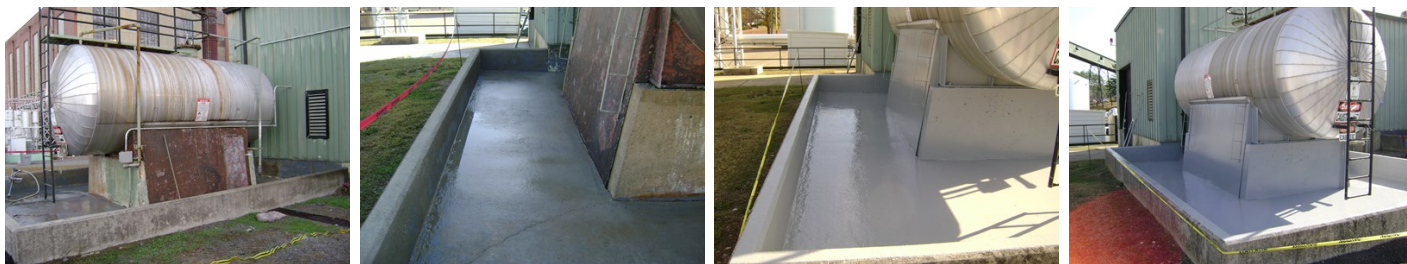
Customers Caustic Containment Area coating had failed and needed a new impervious coating installed.

\* Containment before old coating removed , \* Containment after old coating removed , \* & 4. Completed application ,

Application was carried out in accordance with Belzona Know-How System Leaflet TCC-15. Old coating was removed using high pressure water blasting. Belzona® 5811 was applied to both containment and tank stands.
