# BELZONA PROTECTS 98% SULFURIC ACID CONTAINMENT AREA

ID: 1207

Industry: Power  
Application: TCC-Tanks and Chemical Containment Areas  
Substrate: Concrete  
Products: Belzona® 4311 (Magma CR1)

Customer Location: Power Plant, Alabama USA  
Application Date: December 2007

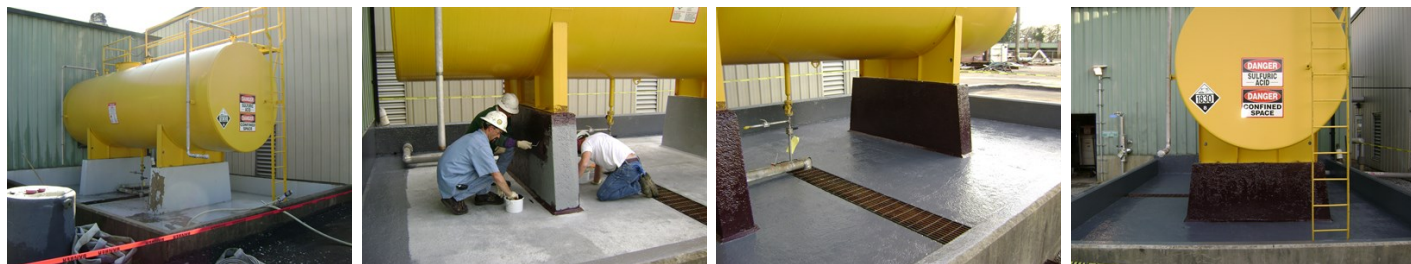
Sulfuric Acid containment area coating had failed and needed re-coating.

\* Old coating being removed , \* Belzona® 4311 being applied , \* & 4. Completed application ,

Application was carried out in accordance with Belzona Know-How System Leaflet TCC-15. Old coating was removed using high pressure water blasting. Belzona® 4311 was applied to both containment and tank stands.
