BELZONA SEALS JOINTS IN UNDERGROUND PIPELINE

Customer Location: *Power plant, Western Kentucky*
Application Date: *2007*

Underground Concrete Pipes from the Cooling Tower to the Condensor.

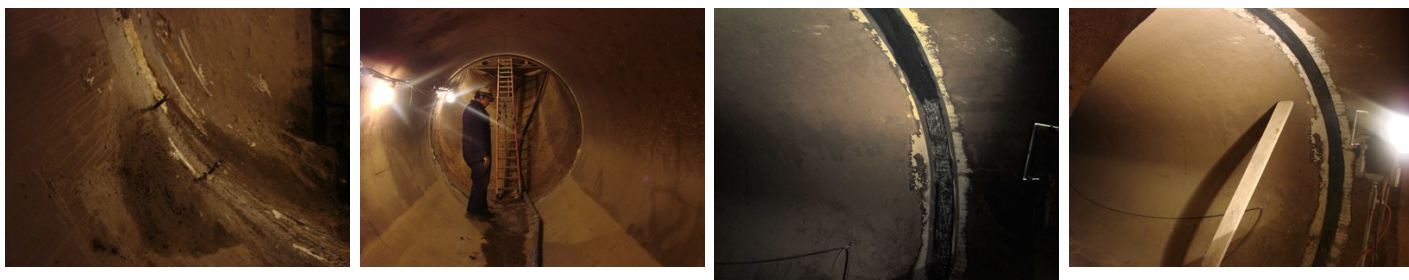
Photograph Descriptions

Power Plant was losing the cooling water through the expansion joints at the concrete pipe junctions.

- * Joints before the application of Belzona ,
- * Joints before the application of Belzona ,
- * Application of Belzona® 2211 ,
- * Completed application ,

Application was carried out in accordance with Belzona Know-How System Leaflets HEX-13a and 13b. Joints were grit blasted before Belzona® 4111 was used to repair joint edges. Finally joints were sealed with Belzona® 2211.
