# BELZONA SEALS JOINTS IN UNDERGROUND PIPELINE

**Industry:** Buildings & Structures  
**Application:** CEP-Centrifugal Pumps  
**Substrate:** Concrete  
**Products:** \* Belzona® 4111 (Magma Quartz) ,  
\* Belzona® 2211 (MP Hi Build Elastomer) ,

**Customer Location:** Power plant, Western Kentucky  
**Application Date:** 2007

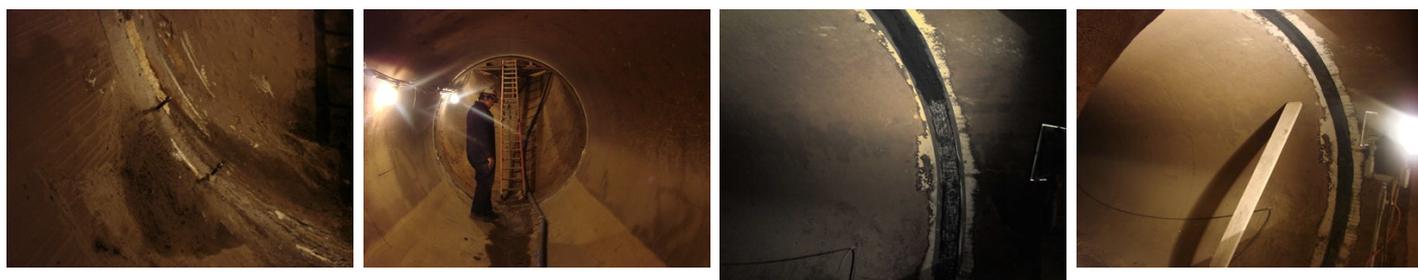
Power Plant was losing the cooling water through the expansion joints at the concrete pipe junctions.

- \* Joints before the application of Belzona ,
- \* Joints before the application of Belzona ,
- \* Application of Belzona® 2211 ,
- \* Completed application ,

Application was carried out in accordance with Belzona Know-How System Leaflets HEX-13a and 13b. Joints were grit blasted before Belzona® 4111 was used to repair joint edges. Finally joints were sealed with Belzona® 2211.
