TANK BASE SEALING WITH BELZONA PRODUCT

ID: 1240

Corrosion at chine angle and water getting under the tank bottom

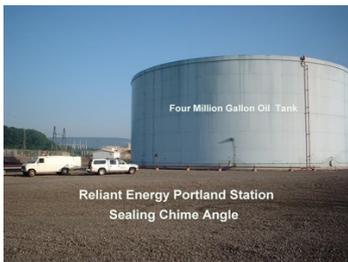
- * View of the tank ,
- * Chime angle before application ,
- * & 4. Finished application ,
