# BELZONA PROTECTS RISER IN SPLASH ZONE

ID: 1242

Customer Location: *Offshore Platform, Adriatic Sea*  
Application Date: *August 2008*

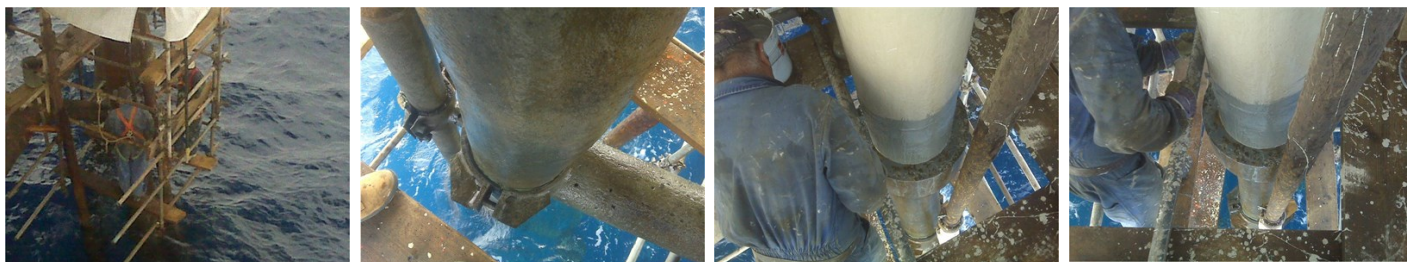
*Corrosion on splash zone*

\* Surface preparation by grit- blasting , \* Washed application area following blasting , \* Applying first coat of Belzona® 5831 , \* Applying second coat of Belzona® 5831 ,

Riser splash zone from the rubber boot to approximately 3.0m above the water

The application was carried out in accordance with Belzona Know-How System Leaflet SOS-21. Surface preparation by grit-blasting (garnet) followed by two coats of Belzona® 5831 applied to the area.

Belzona system was chosen for its ease of application and Belzona® 5831 specifically for its surface tolerance and ability to cure in wet conditions.
