BELZONA PROTECTS STAINLESS STEEL FROM ACID FUMES

Industry: General Industry
Application: TCC-Tanks and Chemical Containment Areas
Substrate: Stainless steel
Products: Belzona® 5811 (Immersion Grade)

Customer Location: Fertilizer manufacturer, Egypt.
Application Date: June 2008.

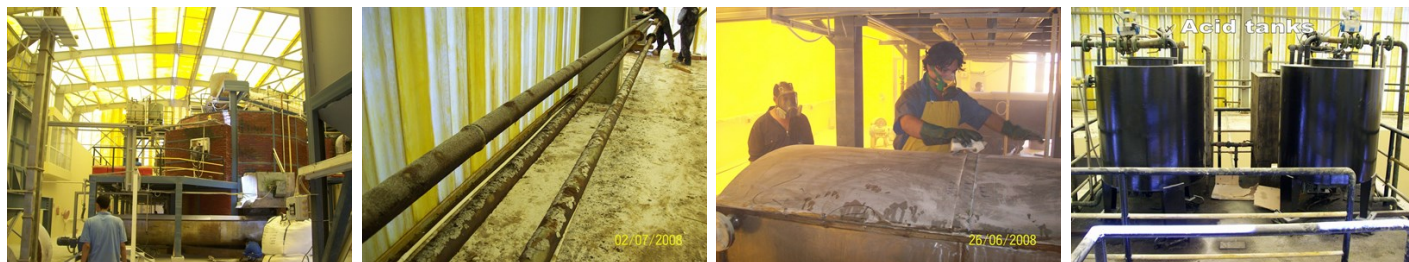
Photograph Descriptions

Stainless steel suffering corrosion and attack from HCl fumes generated in the production process.

* General view to the factory , * Corroded stainless steel pipes , * Cleaning the surfaces , * Application completed ,

Application was carried out in accordance with Belzona Know-How System Leaflet TCC-1

Belzona® 5811 provided a cost effective solution to this problem, having good resistance to the fumes and being easily applied to the various surfaces.
