BELZONA SAVES RECYCLING DRUM FOR SECOND TIME

Industry: Pulp & Paper
 Application: TCC-Tanks and Chemical Containment Areas
 Substrate: Carbon steel and incompatible weld.
 Products: * Belzona 1311 (Ceramic R-Metal) ,
 * Belzona 1321 (Ceramic S-Metal) ,

Customer Location: Paper Mill, North America
 Application Date: 1997 & March, 2009

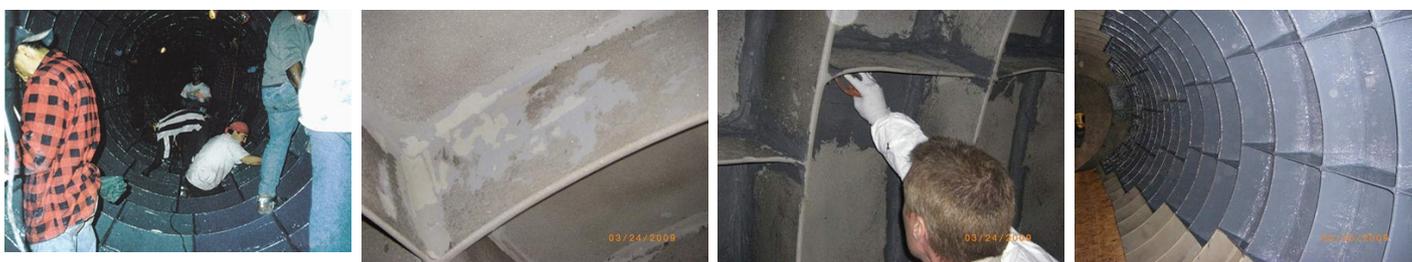
Photograph Descriptions

Bi-metallic corrosion on approximately 70% of the un-protected welds found in 1997. Belzona system applied and inspection of the application after 12 years proves that Belzona provided the right solution for the problem. Belzona was selected to be re-applied to further protect the drum.

- * Original application in 1997 ,
- * After grit blasting Belzona still protecting the critical welds after 12 years. ,
- * Belzona 1311 being applied ,
- * Completed project after application of Belzona 1321 ,

The application was carried out in accordance with a modified version of Belzona Know-How Leaflet TCC-5.

millions of dollars in replacement cost and downtime. The customer can rest assured that this drum will be protected for a long time with this second application of Belzona.
