FLOW CONTROL VALVE REFURBISHED WITH BELZONA

ID: 1276

Customer Location: WasteWater Plant, Jordan

85cm diameter control valve at the biggest wastewater treatment plant in Jordan.

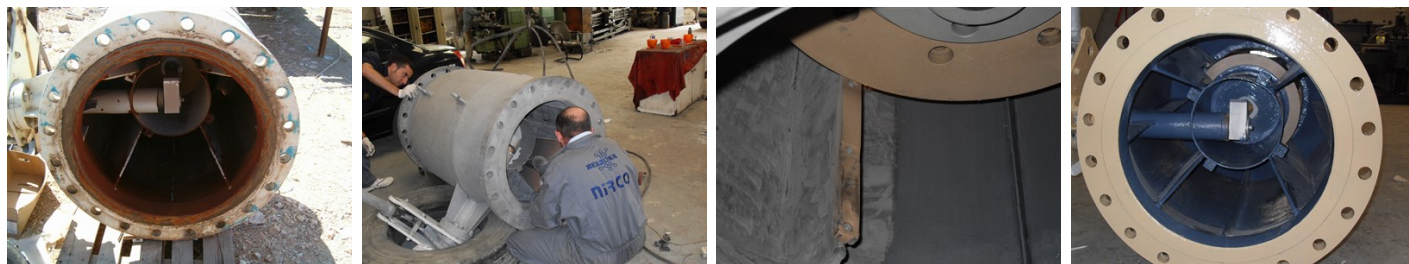
Corrosion and erosion on internal surfaces caused by sewage water.

* General view of the valve , * Rebuilding internal surfaces , * Internal surfaces rebuilt and half coated , * Valve coated internally and externally ,

Application was carried out in accordance with Belzona Know-How System Leaflets CEP-3, -4 and -5.
