BELZONA STANDARD PROTECTION OF SCREW CONVEYOR FOR SOAP PRODUCTION

ID: 1279

Application: *SHM-Solids Handling Machinery*

Application Date: *September, 2008*

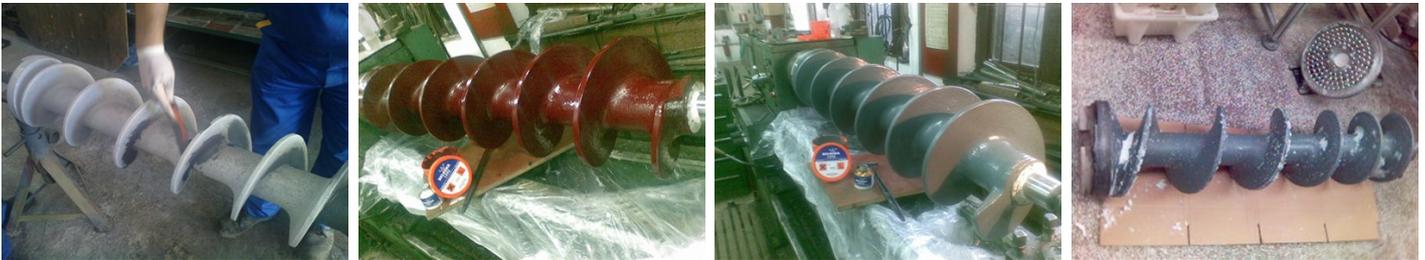
Photograph Descriptions

Erosion/corrosion causes pitting damage on screw conveyor surface accentuated by the high working temperatures (more than 60°C), high pressure injection and corrosive chemical process media.

- * Surface damages repaired with Belzona® 1111 ,
- * First coat of Belzona® 1392 (red) completed ,
- * Second coat of Belzona® 1392 (grey) completed ,
- * Inspection of screw after two months in working conditions ,

Application was carried out in accordance with Belzona Know-How System Leaflet SHM-14. Surface preparation was made in accordance with the Colgate-Palmolive procedure in Belzona approvals (Refurbishing and Coating Silumin Worms for Soap Plodders).

Two screw conveyors with OD 250 mm and 300 mm were protected with a third to be completed. Inspection review two months after application revealed only slight discolouring and loss of gloss. Belzona is routinely specified by this International soap producer for protection of these screws.
