INVISIBLE BELZONA PROTECTION FOR CHAPEL

ID: 1298

Industry: *Buildings & Structures*
Application: *WPA-Wall Problem Areas*
Substrate: *Masonry and Brickwork*
Products: ** Belzona® 5122 (Clear Cladding Concentrate),*

Customer Location: *Borough Council, UK*
Application Date: *2009*

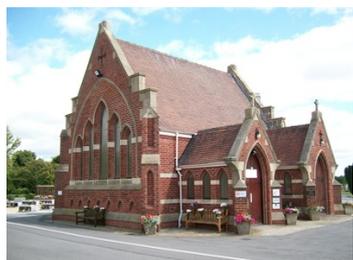
Aging mortar for masonry and brickwork had become porous. Water was persistently penetrating the structure, creating damp areas on internal walls. The Council wished to retain the original appearance of the structure.

- * Chapel of Remembrance - Front ,
- * Chapel of Remembrance - Rear ,
- * Parapet Wall Sections Protected with Belzona® 5122 ,

Application was carried out in accordance with Belzona Know-How System Leaflet WPA-8. Once the brickwork had been repointed, all parapet wall areas were protected with a single coat of Belzona® 5122.

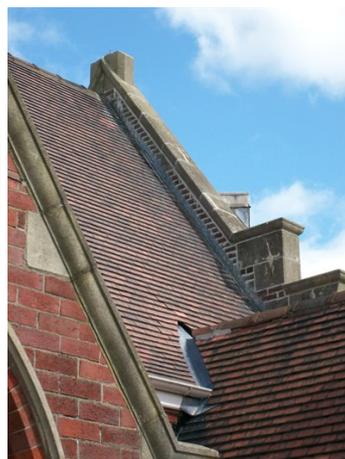
Parapet Walls on Crematorium Chapel of Remembrance

The contractor has used Belzona repeatedly to offer premium weather protection on porous masonry. Belzona® 5122 offered water repellent surface which was ideal for this building where they required to retain a natural look to the masonry surface.
