# INVISIBLE BELZONA PROTECTION FOR CHAPEL

ID: 1298

Parapet Walls on Crematorium Chapel of Remembrance

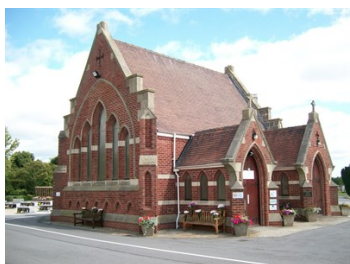
Aging mortar for masonry and brickwork had become porous. Water was persistently penetrating the structure, creating damp areas on internal walls. The Council wished to retain the original appearance of the structure.

- \* Chapel of Remembrance - Front ,
- \* Chapel of Remembrance - Rear ,
- \* Parapet Wall Sections Protected with Belzona® 5122 ,

Application was carried out in accordance with Belzona Know-How System Leaflet WPA-8. Once the brickwork had been repointed, all parapet wall areas were protected with a single coat of Belzona® 5122.
