# BELZONA PROTECTS RIVER TEES

ID: 1299

Riverside Bunds for Generators and Oil Storage

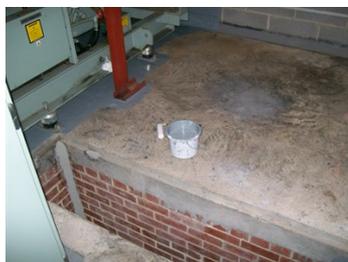
- \* Riverside location of the office facilities ,
- \* Generator room during application with covings completed ,
- \* Generator room completed ,
- \* ,

Application was carried out in accordance with Belzona Know-How System Leaflet TCC-15. Covings and fillets were formed with Belzona® 4131 and Belzona® 4141 prior to sealing area with Belzona® 5811.
