BELZONA PROTECTS RIVER TEES

Riverside Bunds for Generators and Oil Storage

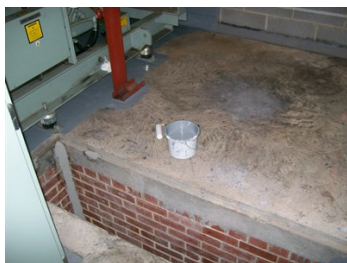
- * Riverside location of the office facilities ,
- * Generator room during application with covings completed ,
- * Generator room completed ,
- * ,

Application was carried out in accordance with Belzona Know-How System Leaflet TCC-15. Covings and fillets were formed with Belzona® 4131 and Belzona® 4141 prior to sealing area with Belzona® 5811.
