HOPPERS LINED WITH BELZONA FOR EXTENDED LIFE

ID: 1335

Customer Location: *Manufacturer of asphalt shingles,
Canada*

Application: *SHM-Solids Handling Machinery*

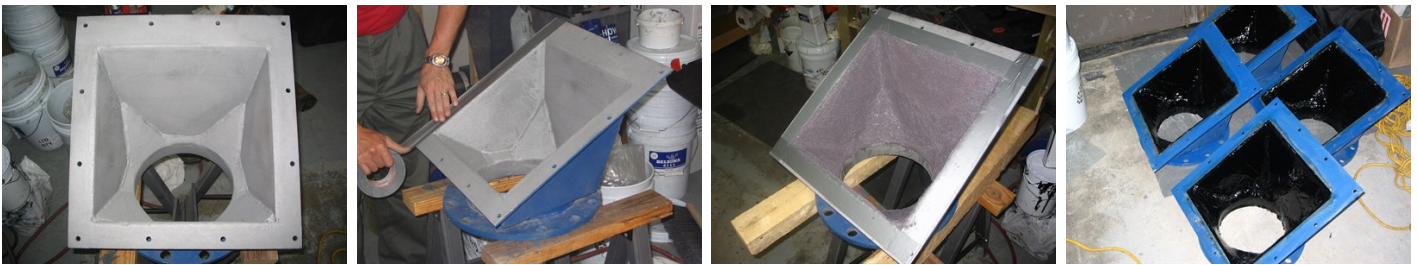
Unloading of solids, composed of fine stone approximately 1/32" diameter, creating high abrasion on the inside surface of the hoppers.

- * Hopper grit blasted ,
- * Masking prior to application ,
- * Application of Belzona® 1812 ,
- * Hoppers lined with Belzona® 2111 ,

Application was carried out using Know-How System Leaflet SHM-13. Belzona® 1812 applied to profile the hopper before overcoating with Belzona® 2111. Both mild steel hopper and Belzona® 1812 grit blasted before coating.

the hopper had a life expectancy of 1 month. Other solutions lasted 7 months. With the Belzona solution equipment now operates for a period of 18 to 24 months maintenance free. They even carry 1 or 2 hoppers in stock. Client approved the Belzona® 1812 as an inventory product and is used in other applications.
