# BELZONA PREPARES VERTICAL PUMP FOR ACID SERVICE

ID: 1339

**Customer Location:** Refinery, Canada  
**Application Date:** May 2005

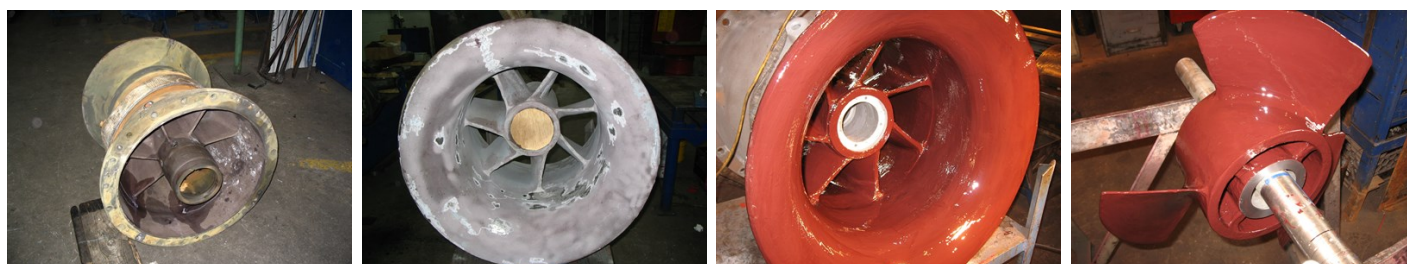
Chemical attack inside volute and on the impeller.

- \* Original pump after 5 years ,
- \* The volute after surface preparation ,
- \* The volute after coating with Belzona® 4311 ,
- \* The impeller protected with Belzona® 4311 ,

Vertical pumps to handle sulfuric acid

Application was carried out in accordance with Belzona System leaflet CEP-3.

Belzonas solution for acid pumps was originally tested in 1998 on a vertical pump in contact with 93% sulfuric acid. Very satisfying results led to 5 identical pumps 4 years later being protected.

Belzona 4311, designed to withstand immersion in such aggressive chemicals, once more proved that it is a very cost effective maintenance solution for equipment.
