# BELZONA MAINTAINS THE FLOW

Industry: *Pulp & Paper*  
Application: *CEP-Centrifugal Pumps*  
Substrate: *Cast Iron*  
Products: *\* Belzona® 1341 (Supermetalgilde) ,*

Customer Location: *Paper Mill, Ontario*  
Application Date: *April, 2009*

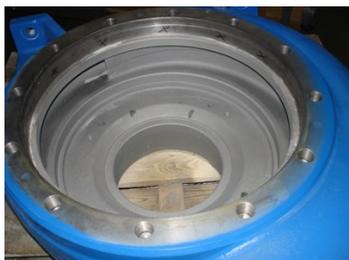
- \* 1 & 2 Internal surfaces grit blasted ,
- \* 3. Belzona 1341 applied ,
- \* 4. Completed application ,

Application was carried out in accordance with Belzona Know-How System Leaflet CEP-3. Casing and impeller were blasted to achieve a 3 mil profile and 2 coats of Belzona® 1341 were applied.
