BELZONA SOLVES PROBLEM OF CORROSIVE ATTACK ON COPPER BAFFLES IN SUBMARINE

ID: 135

Customer Location: *Submarine Manufacturer in Connecticut*
Application Date: *Autumn 1995*

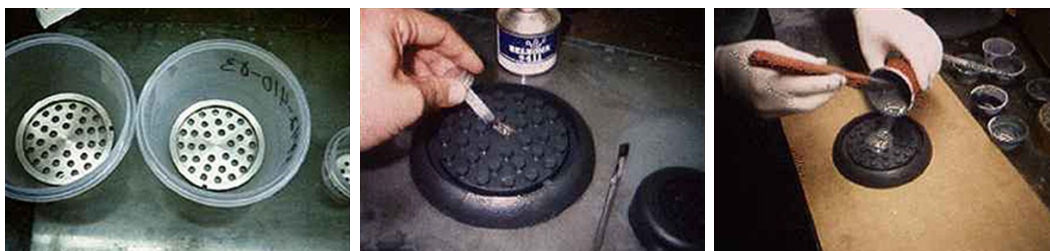
Photograph Descriptions

The baffles are subject to erosion and corrosive attack. The customer required a material that could be cast and would be resistant to erosion and corrosion.

- * Prototypes to make mould ,
- * Belzona® 9411 applied to mould ,
- * Pouring Belzona® 1321 ,

Copper baffle plates in submarine waste-water treatment system

In accordance with Belzona Know-How Leaflets MPT-10 and RPA-9.

This application removes the necessity for replacing the baffles on a regular basis. The savings for the submarine operator could be substantial.
