# BELZONA NON-STICK COATING FOR ICE CUBE IMPELLER

Industry: *General Industry*  
Application: *CEP-Centrifugal Pumps*  
Substrate: *Stainless Steel*  
Products: *\* Belzona® 1341 (Supermetalgilde) ,*

Customer Location: *Chemical Plant in Argentina*  
Application Date: *December 1995*

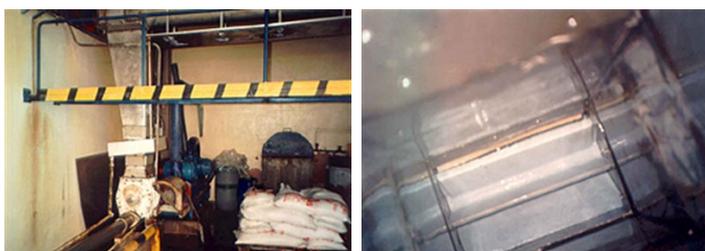
*The ice cubes are manufactured on a large scale and distributed to the various units of the plant. They stick to the impeller, clogging the system and affecting production.*

- \* View of the ice distribution system ,
- \* The impeller as seen through the inspection hatch, coated with Belzona® 1341 ,

The customer had tried other coatings in an attempt to solve the problem but only the Belzona® 1341 achieved the desired effect. There is no longer a need to wash or chip the ice off the impeller vastly reducing the downtime of the plant. The customer is now considering applying the same treatment to the next part of the distribution system, a stainless steel worm which suffers the same problems.
