# BELZONA KEEPS THE BEANS DRY

**Industry:** General Industry  
**Application:** CEP-Centrifugal Pumps  
**Substrate:** steel and concrete  
**Products:** \* Belzona® 6111 (Liquid Anode) ,  
\* Belzona® 3921 (GSC) ,  
\* Belzona® 3111 (Flexible Membrane) ,

**Customer Location:** Bean processor, Manning, Iowa  
**Application Date:** April 2009

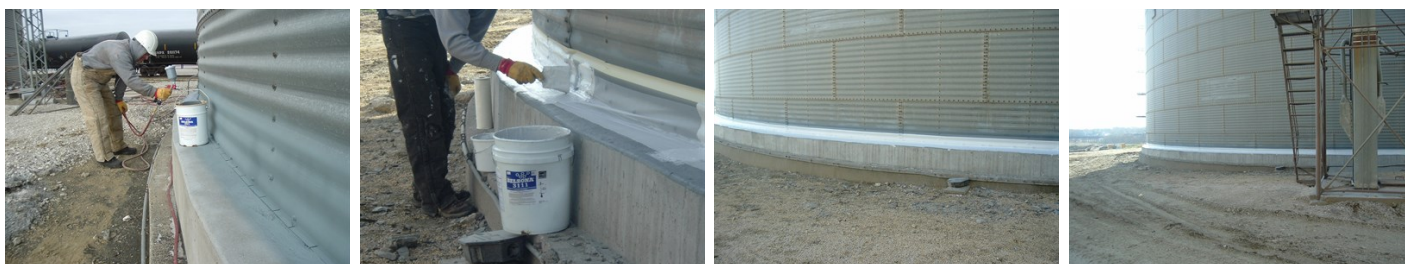
Water ingress between tank and concrete tank base. For several years tar was applied but continually failed.

- \* Belzona® 6111 applied and Belzona® 3921 being applied ,
- \* First coat of Belzona® 3111 with Reinforcing sheet being applied ,
- \* Completed application ,
- \* Completed application, general view ,

Applying tar around the tank base had proven to be very temporary and unsuccessful. Belzona® 6111 provides excellent corrosion protection to steel wall and Belzona® 3111 provides flexible weatherproof seal. Customer was so pleased with the results of Belzona that 3 more tanks are scheduled for the same treatment.
