BELZONA KEEPS THE BEANS DRY

Industry: General Industry
Application: CEP-Centrifugal Pumps
Substrate: steel and concrete
Products: * Belzona® 6111 (Liquid Anode) ,
* Belzona® 3921 (GSC) ,
* Belzona® 3111 (Flexible Membrane) ,

Customer Location: Bean processor, Manning, Iowa
Application Date: April 2009

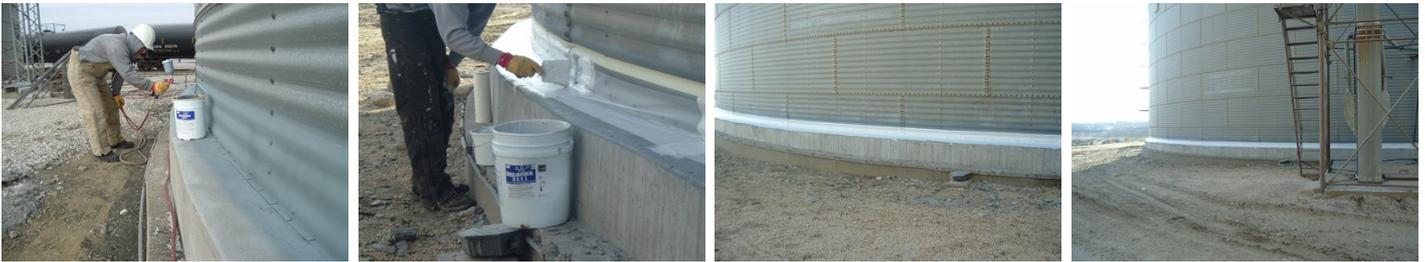
Water ingress between tank and concrete tank base. For several years tar was applied but continually failed.

- * Belzona® 6111 applied and Belzona® 3921 being applied ,
- * First coat of Belzona® 3111 with Reinforcing sheet being applied ,
- * Completed application ,
- * Completed application, general view ,

Applying tar around the tank base had proven to be very temporary and unsuccessful. Belzona® 6111 provides excellent corrosion protection to steel wall and Belzona® 3111 provides flexible weatherproof seal. Customer was so pleased with the results of Belzona that 3 more tanks are scheduled for the same treatment.
