# PUMP DIFFUSER REPAIR SURPASSES ALL EXPECTATIONS WITH BELZONA

Industry: Power  
 Application: CEP-Centrifugal Pumps  
 Substrate: Cast Iron  
 Products: \* Belzona® 1311 (Ceramic R-Metal) ,  
 \* Belzona® 1321 (Ceramic S-Metal) ,  
 \* Belzona® 5811 (Immersion Grade) ,

Customer Location: National Electricity Provider, Malta  
 Application Date: May 2000

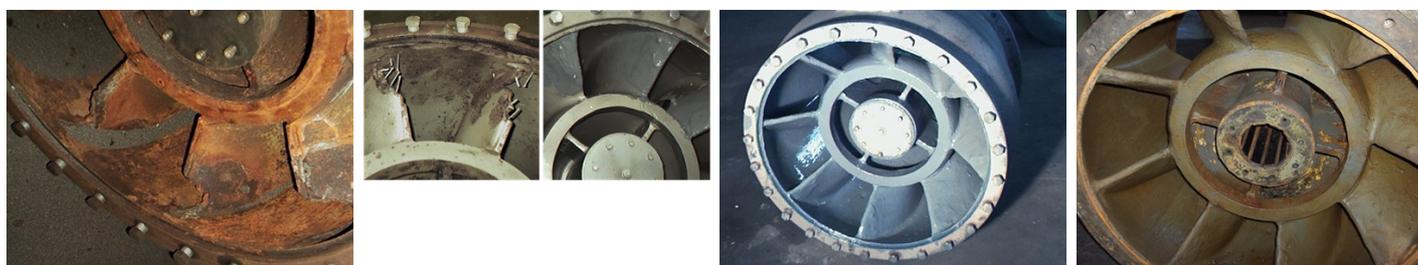
## Photograph Descriptions

Efficiency losses and pump breakdown due to severe erosion-corrosion of the single vertical axial flow pump (7090 m<sup>3</sup>/h). Prior to the Belzona solution, the client had to replace the pump components annually. As a significant local electricity supplier, downtime of this critical equipment caused major problems.

- \* Condition of the pump diffuser after 1 year in service ,
- \* Rebuilding of the vane profiles ,
- \* The finished application ,
- \* Application after 9 years service ,

The application was carried out in accordance with Belzona Know-How System Leaflets CEP-1, CEP-3 and CEP-4.

The customer was surprised that the eroded equipment could be repaired and delighted with the vastly improved reliability and performance. The pump casing and suction bell were also coated and protected internally and externally. After 9 years in service,

the coating was found to still be in excellent condition.
