BELZONA KEEPS THE SHOWERS HOT & CLEAN AT HOTEL

Industry: Water / Wastewater
Application: HEX-Heat Exchangers
Substrate: Steel
Products: * Belzona® 1511 (Super HT-Metal) ,
* Belzona® 1391 (Ceramic HT Metal) ,

Customer Location: International Hotel, Malta
Application Date: August 2005

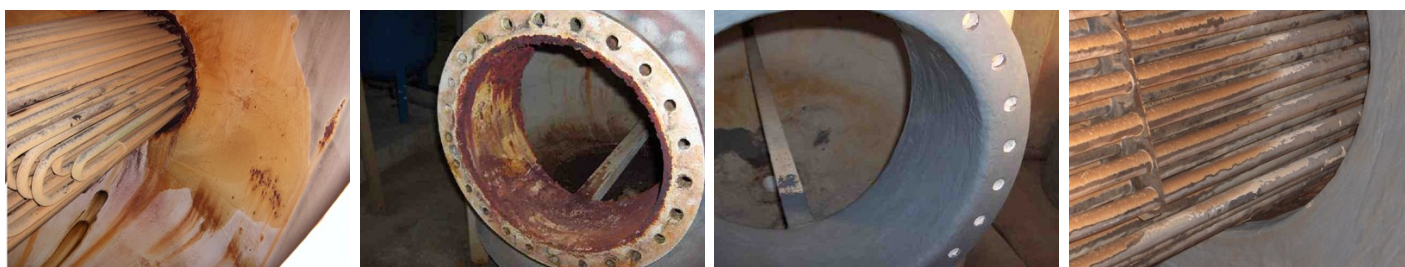
Photograph Descriptions

Breakdown of the original coating system had resulted in severe corrosion, deep pitting and through holes around the heating bundle. In addition the corrosion led to discolouring of the hot water supply in this prestige international hotel, leading to customer complaints.

- * Corrosion damage after failure of the original coating ,
- * Tube bundle nozzle, before preparation for coating ,
- * Completed application ,
- * Inspection after 8 months in service ,

The client was looking for a quick and economic long term solution to this image damaging problem. Only the affected area was rebuilt and the Belzona coating overlapped onto the original coating. An initial inspection after 8 months showed no breakdown and the solution was subsequently applied to the second calorifier. After 4 years in operation the hotel maintenance manager confirmed

that the Belzona coating is in the same perfect condition.
