# BELZONA PROTECTS 35 GATE VALVES FOR REFINERY

ID: 1380

Customer Location: Petrochemical Company, Sultanate of Oman

Application: VPF-Valves, Pipes and Fittings

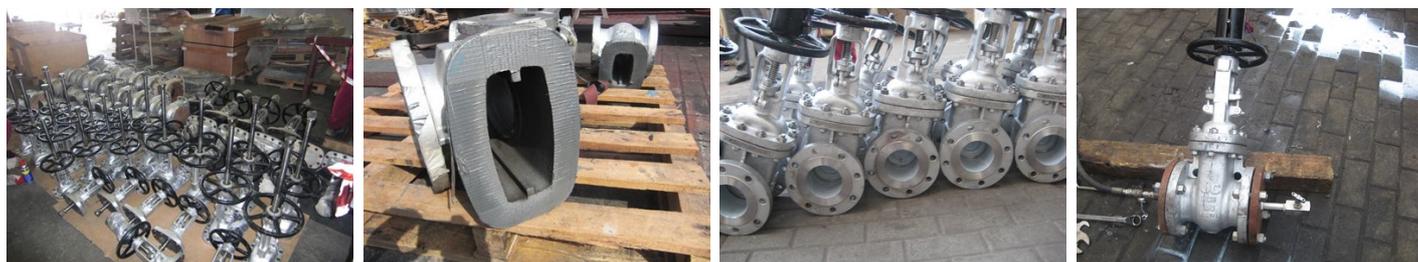
## Photograph Descriptions

All existing valves were suffering severe corrosion from the sea water so new valves being protected as part of preventative maintenance programme.

- \* Valves open for inspection ,
- \* Internal surfaces grit blasted ,
- \* Belzona® 1341 application complete after applying 2 coats ,
- \* Assembled valve undergoing pressure test ,

35 new valves acquired for expansion of plant. These valves control the flow of sea water into the plant

Application was carried out in accordance with Belzona Know-How System Leaflet VPF-2

Belzona coating provides proven corrosion protection required to meet the expansion plants need for preventative maintenance.
