# BELZONA PROTECTS 35 GATE VALVES FOR REFINERY

**Customer Location:** Petrochemical Company, Sultanate of Oman

**Application:** VPF-Valves, Pipes and Fittings

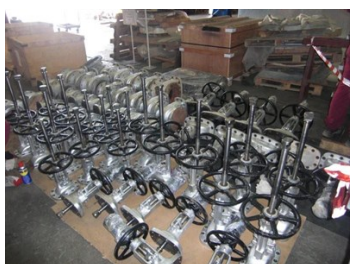
All existing valves were suffering severe corrosion from the sea water so new valves being protected as part of preventative maintenance programme.

- \* Valves open for inspection ,
- \* Internal surfaces grit blasted ,
- \* Belzona® 1341 application complete after applying 2 coats ,
- \* Assembled valve undergoing pressure test ,
