# BELZONA REPAIRS HOLED CLARIFIER

ID: 1402

**Customer Location:** Chemical plant, New Jersey USA  
**Application Date:** August 2008

Waste Water tank at a Chemical Plant

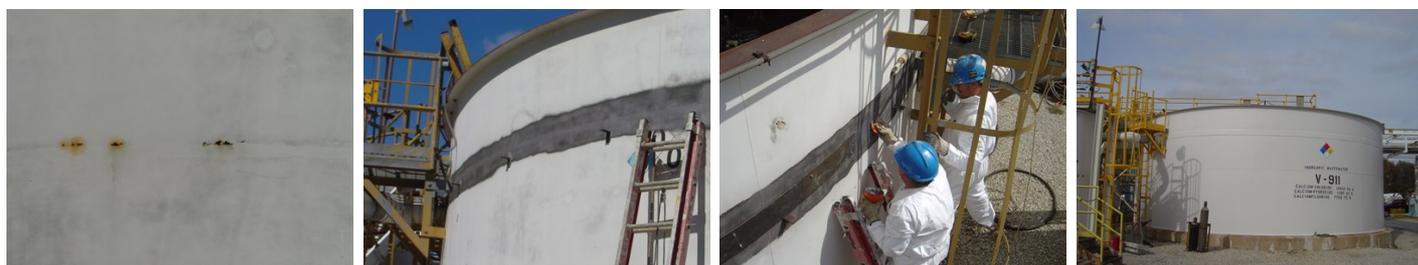
Corrosion along the water line had resulted in a series of holes and thin areas around the entire circumference of the tank.

- \* Holes in tank wall ,
- \* After grit blasting supports were bonded with Belzona® 1211 ,
- \* Belzona® 1121 being applied to shell ,
- \* Exterior completed ,

Application was carried out in accordance with Belzona Know-How System Leaflet TCC-1. Angle iron was bonded with Belzona® 1211 to the tank to support fabricated steel bands during application. Belzona® 1121 was used in conjunction with self tapping screws to bond the band to the tank wall. The interior of the tank was coated with Belzona® 5811 and the exterior painted.
