# BELZONA EXPANSION JOINT THREE YEARS ON

**Industry:** Buildings & Structures  
**Application:** FPA-Floor Problem Areas  
**Substrate:** Concrete  
**Products:** \* Belzona® 4111 (Magma Quartz),  
\* Belzona® 2211 (MP Hi-Build Elastomer),  
\* Belzona® 4411 (Granogrip),

**Customer Location:** Hospital, Charlotte, North Carolina, USA  
**Application Date:** March, 2006

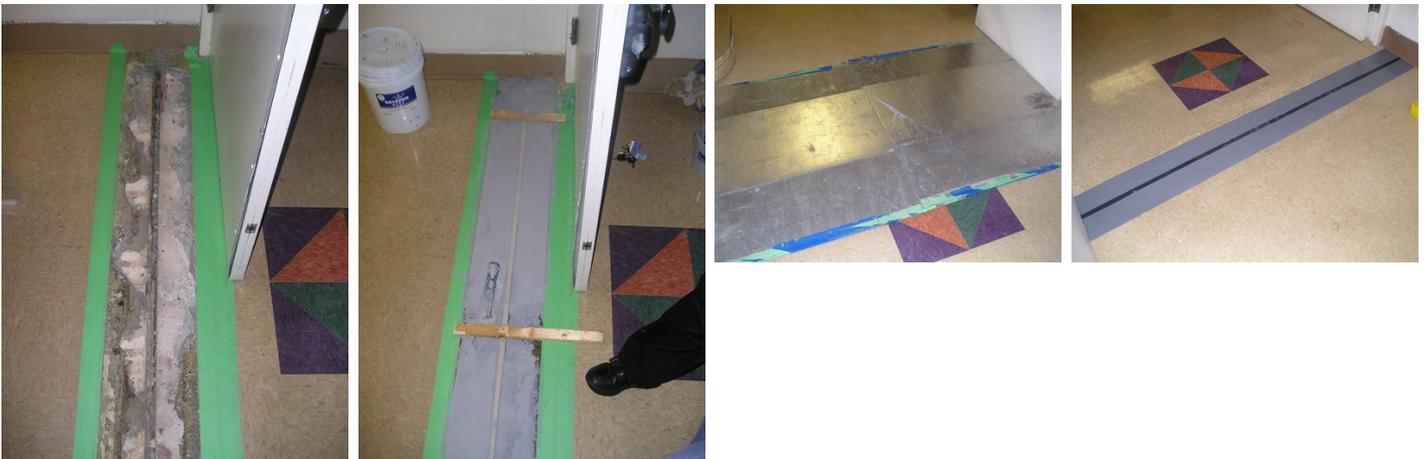
The expansion joint had failed and was causing a trip hazard, as well as making hospital guests uncomfortable when rolled in their beds or wheelchairs across the failed joint. Metal plate put over top was a trip and bump hazard.

- \* Joint taken out and fresh concrete exposed ,
- \* Belzona® 4111 troweled into place ,
- \* Ramp used to cover joint while product is curing ,
- \* Finished joint 3 years on ,

The Belzona application was carried out in accordance with Belzona Know-How System Leaflets FPA-5 & -6. The old metal joint was torn out and replaced with Belzona® 4111. A jig was used to provide the repair with the same height as the tile floor. After removing the joint former, Belzona® 2211 was used to seal the joint. Belzona® 4411 applied for aesthetics.
