# IMPELLER AT NUCLEAR PLANT REPAIRED AND PROTECTED WITH BELZONA

**Customer Location:** Nuclear Power Plant, North Carolina  
**Application Date:** August, 2009

Cooling tower Recirculation pump impeller.

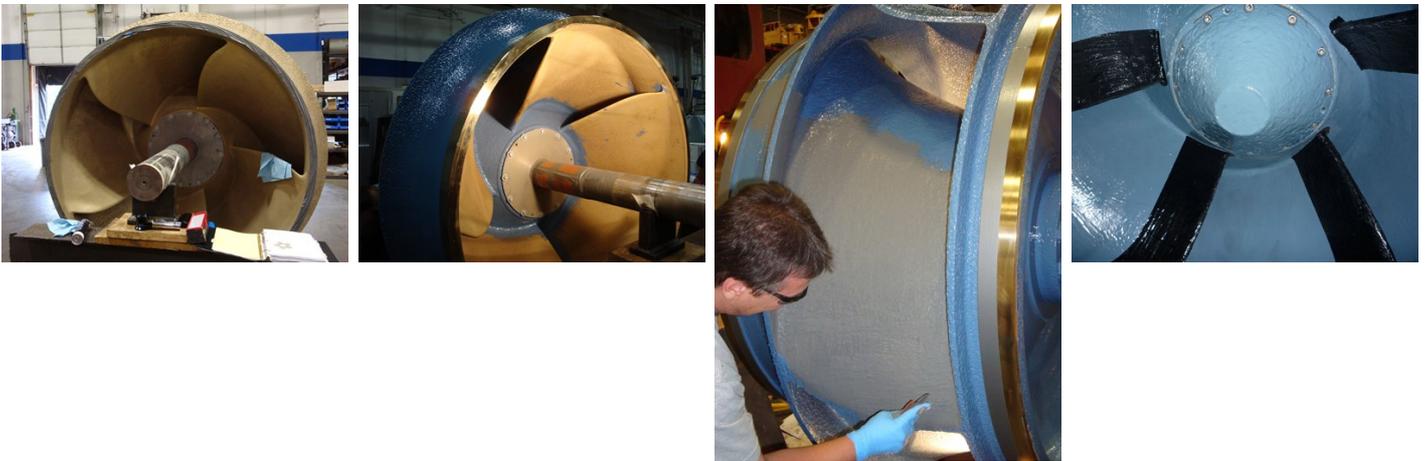
A combination of de-Aluminification over the surface of the impeller and cavitation at root of the vanes was causing a significant reduction in the efficiency of this pump.

- \* Impeller before application of any product ,
- \* Application of the 1st layer of Belzona® 1341 ,
- \* Application of the smoothing layer of Belzona® 1121 ,
- \* Belzona® 2141 applied to complete the job ,

The application was carried out in accordance with Belzona Know-How System Leaflets CEP-1, -3, -5 & -10. Belzona® 1121 used to smooth the surface prior to application of Belzona® 1341 system. Belzona® 2141 was then applied 8" on either side of the vanes to protect from cavitation.
