# BELZONA PROTECTS AMINE STRIPPER COLUMN

ID: 1416

**Customer Location:** Petrochemical Company, Egypt

**Application:** TCC-Tanks and Chemical Containment Areas

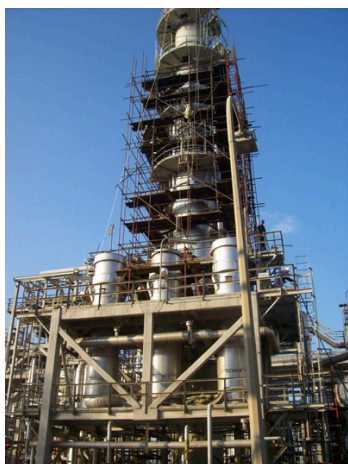
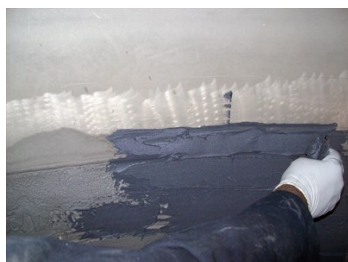
Corrosion had led to a reduction in the wall thickness, forcing a shutdown.

\* 1. General view of the column 2. Application of Belzona 1511 to grit blasted substrate 3. Finished application after pinhole inspection 4. Inspection after 3 years service. ,

Belzona offered a corrosion resistant system for the hot chemical process involved. Metal cladding could not be carried out within the time constraints of this short shutdown. Inspection after 3 years service showed the coating to be in excellent condition.
