# BELZONA FACTORY APPLIED TO CHILLER

ID: 1418

**Customer Location:** Manufacturing Facility, Texas USA  
**Application Date:** 2009

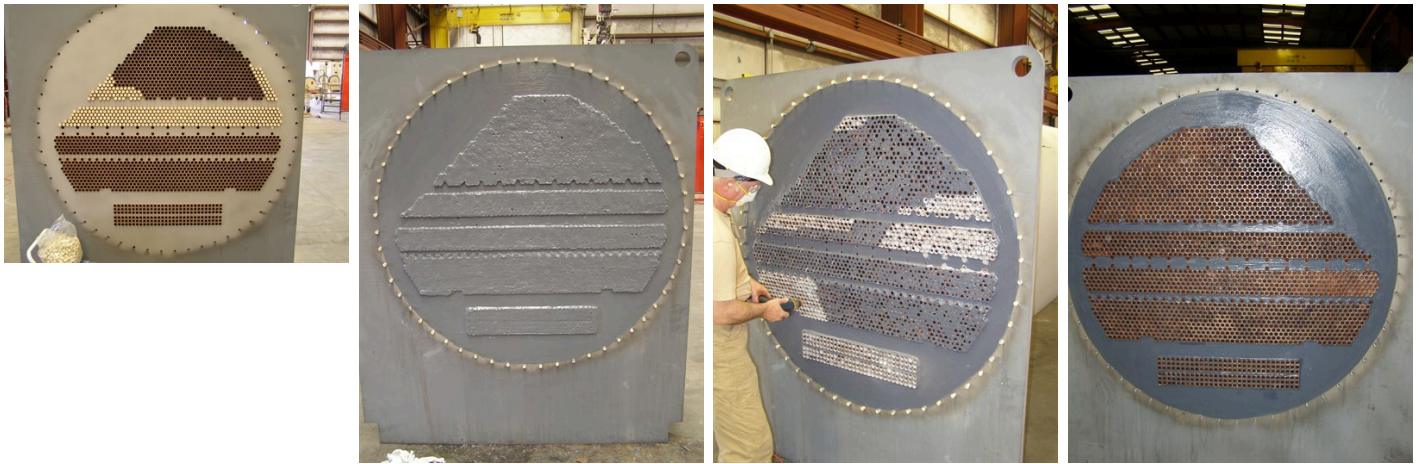
- \* Corking of the tube sheet ,
- \* Built-up tube sheet with one of coat of Belzona® 1321 applied ,
- \* Corks punched in and tube ends being honed ,
- \* Completed tube sheet ,

Application carried out in accordance with Belzona Know-How System Leaflets HEX-1 & -3. After corking tubes, Belzona® 1111 used to ensure the tubes are flush with the surface before applying the Belzona® 1321 system.
