BELZONA KEEPS OS&D HOSE IN SERVICE

ID: 1426

Industry: Marine
Application: SOS-Ships and Offshore Structures

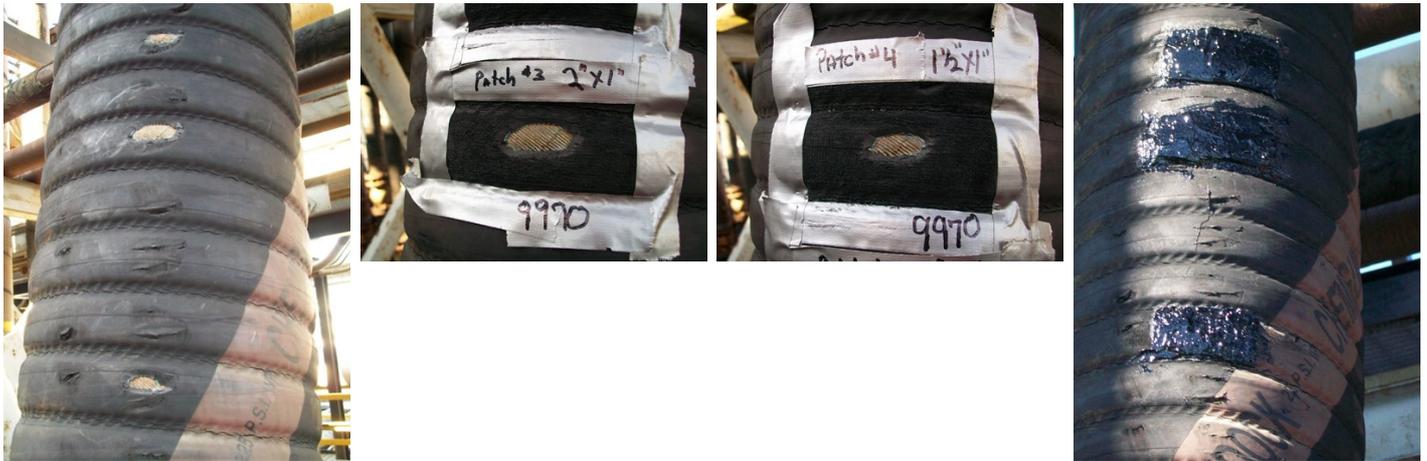
Photograph Descriptions

When inspected by the United States Coast Guard, even superficial scuffs and tears in the outer cover can result in hoses being tagged "out of service". Inspection showed that the reinforcement fabric had not been damaged.

- * Hose #9970 with 3 scuffed up areas exposing reinforcement fabric ,
- * Patch #3 area taped off and abraded ,
- * Patch #4 area taped off with Conditioner applied ,
- * Completed and ready for inspection ,

Scuffs and tears to the cover of 8" OS&D (Oil Suction & Discharge) hoses.

Application was carried out in accordance with Belzona Know-How System Leaflet SOS-12.

A typical 8" OS&D hose can cost \$3500 depending on length. Superficial damage, meaning damage to cover only, is common when dragged over docks and railings. The Coast Guard, however, can require these hoses be retired from service. If there is no damage to the reinforcement fabrics, a Belzona® 2111 patch system, when fully documented with before and after pictures, has been accepted by the USCG. These specific patches cost approx \$1200 in material and labor. 5 patches were installed on three hoses saving the customer approx \$11,000 in replacement costs
