BELZONA PROVIDES LONG TERM PROTECTION OF OBSERVATORY ROOF

ID: 1447

Customer Location: Mills Observatory, Dundee Scotland

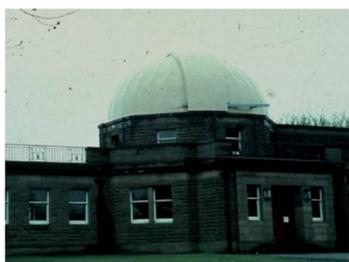
- * Original Application in 1974 ,
- * Refurbishment in 1988 ,
- * Application revisited in 2010 ,
- * Application revisited in 2010 still in perfect condition ,

A fully reinforced Belzona® 3111 System was originally applied in 1974. Following this original Belzona application, the roof was refurbished in 1988 with a single layer of Belzona® 3111 to assure complete weatherproofing for future years. To provide enhanced appearance Belzona® 5151 was applied in 2003.

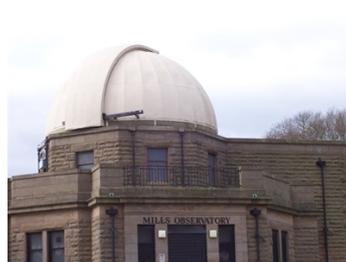
The application was revisited again in 2010 still showing that the application was in perfect condition. The self cleaning properties of Belzona® 5151 continue to maintain the excellent appearance of the roof.
